Learning from Earthquakes

The March 20, 2012, Ometepec, Mexico, Earthquake

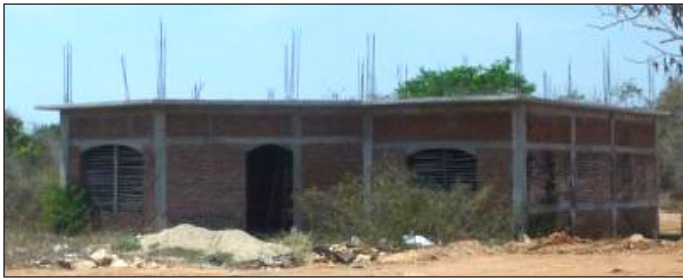
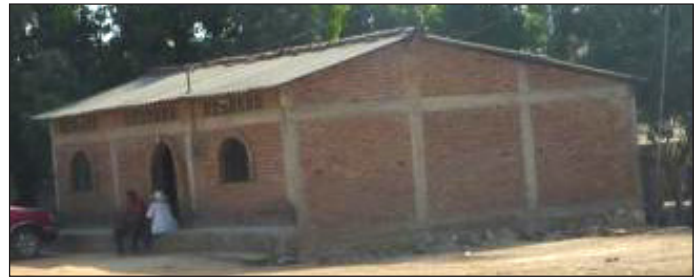
Confined masonry structures. In general, housing and commercial buildings are built with this technique. We found structures that had redundant confined concrete elements (“daldas” and “castillos” — Figure 8). We believe that this is a consequence of moderate earthquakes in the past, local and state seismic provisions, and the intuition of the local construction workers. As the Guerrero area is hot and humid, interstory heights range from 4-5m, and hence they place concrete elements every 1.5m or less, as illustrated in Figure 9. Even though the materials used for the clay bricks and concrete elements might not be of the highest quality, these structures exhibited no damage.

Figure 8a and b. Redundancy of concrete elements in new reinforced masonry structures.

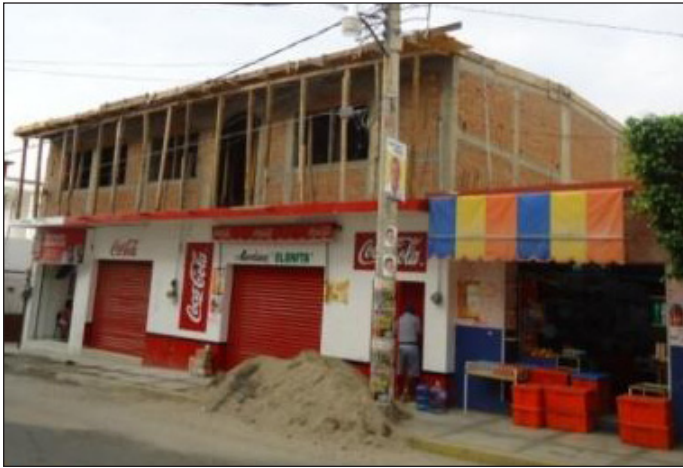
Figure 9. Concrete elements every 1.5m or less.
